EVALUATION OF EPOXIES TO
PROVIDE STRESS-FREE BONDING
OF PYROCERAM MIRRORS.

PREPARED FOR
NIGHT VISION & ELECTRO-OPTICS
LABORATORY, FT. BELVOIR, VA 22060

CONTRACT No. DAAK70-77-C-0186

MAR 1979

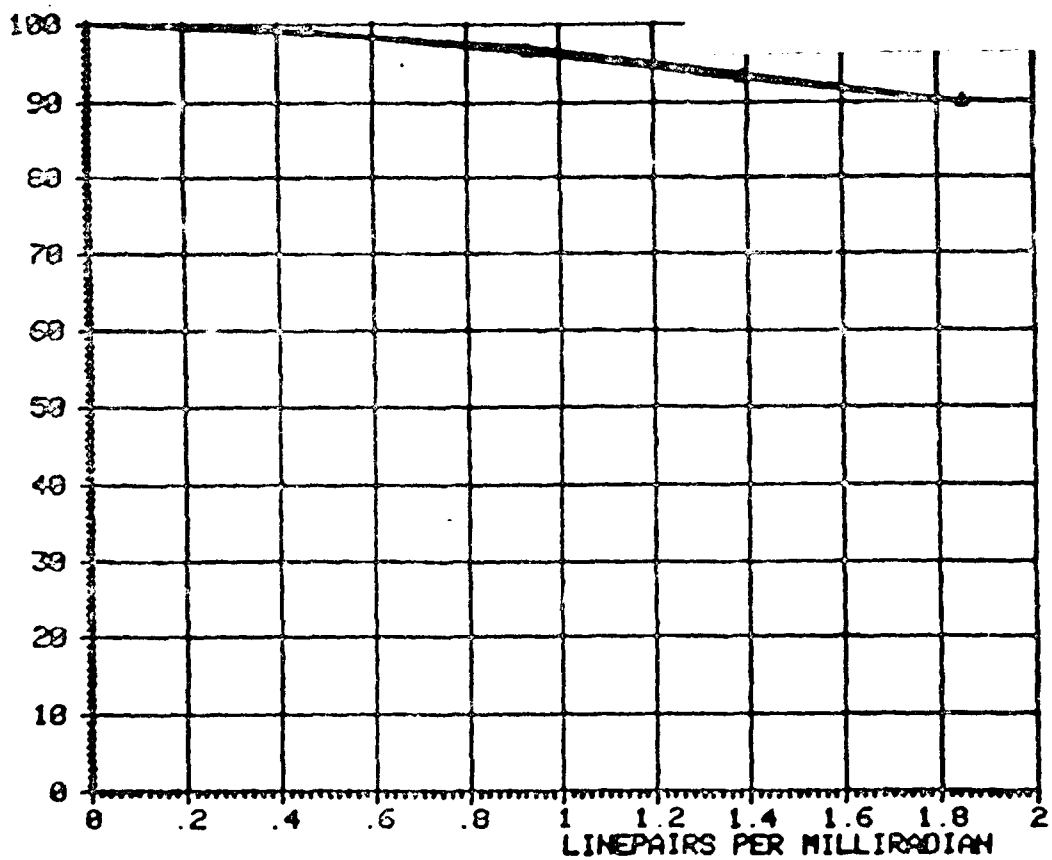
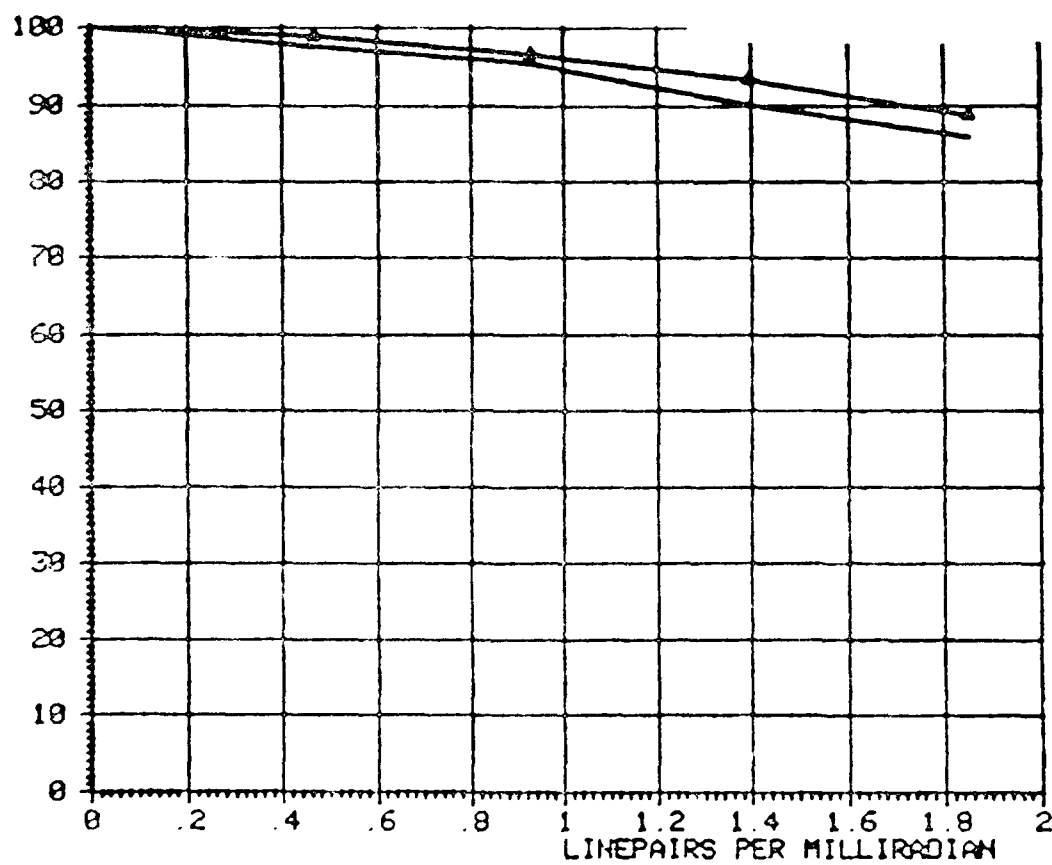
The mirror was then subjected to a MTF test at the NVL facility and Figures 48 and 49 reflect the response of this mirror. The curves achieved for the MTF test indicated that the Visual side showed essentially no astigmatism with a regular elliptical surface in evidence. The IR side shows that the elevation plane response was somewhat better than that of the azimuthal response with some astigmatism involved. It is difficult to interpret the interferogram shown on Figure 47 to determine that this astigmatism is there. However, it becomes evident that the response of the mirror from an interferogram point of view can be misinterpreted to a considerable degree, especially to an inexperienced eye.

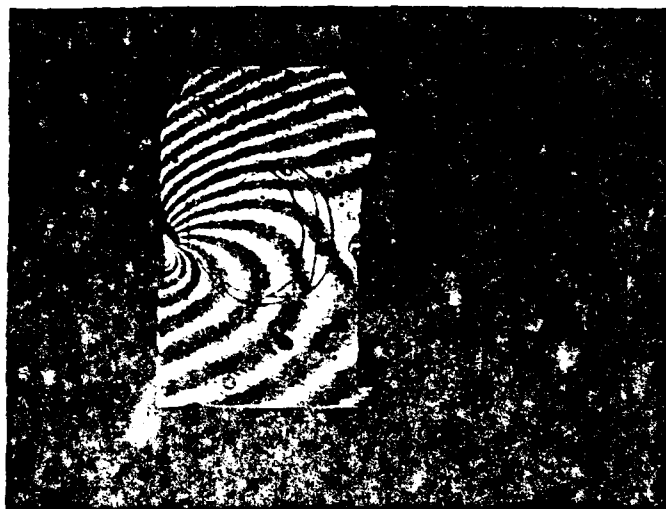
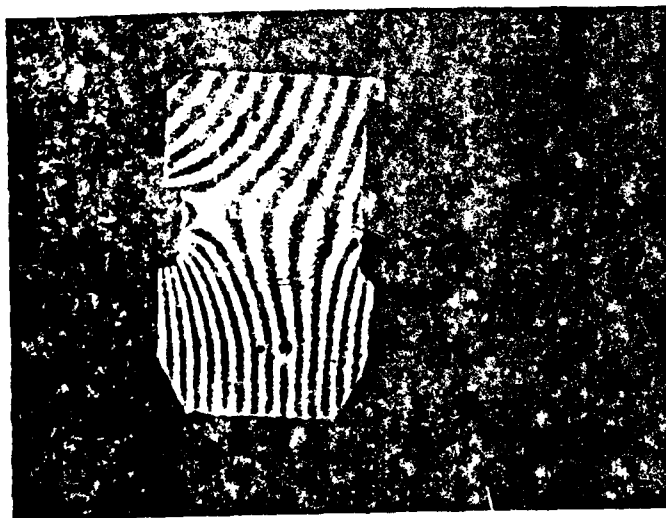
FIGURE 50. INTERFEROGRAMS, S/N 008A

Tests were also run on Mirror #008A which consisted of a different substrate (glass) to isolate the results for two different materials and the same cement (Stycast). The interferograms shown in Figure 50 are self explanatory. The distortion at the top cap and the arm return have not been controlled as in Mirror #008 in spite of every precaution being taken during the assembly process.

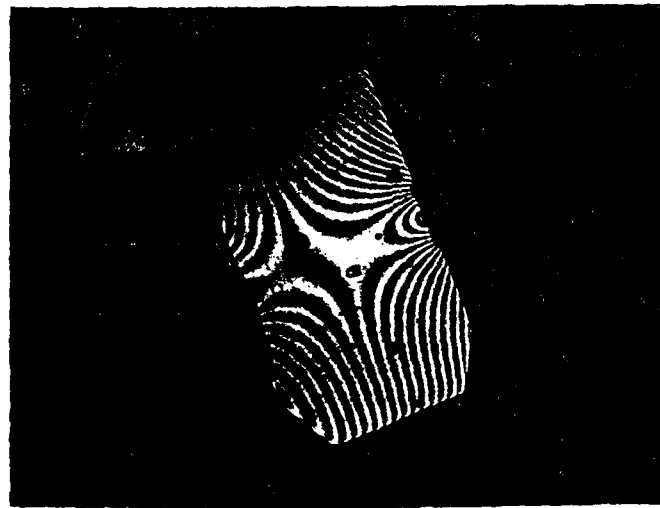
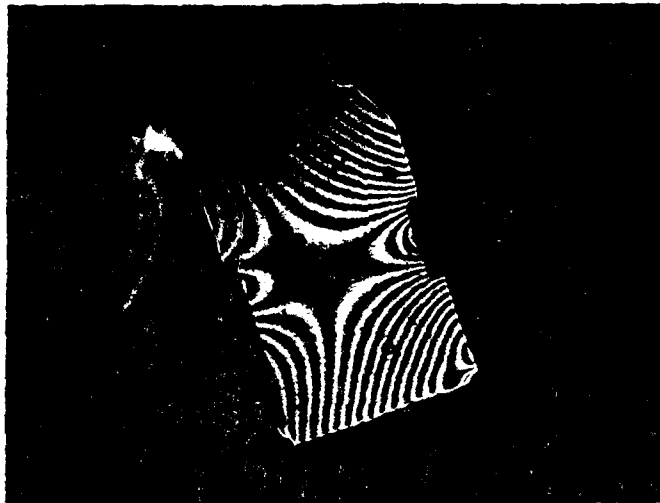
FIGURE 53. INTERFEROGRAMS, IR & VISIBLE SIDES, S/N 009

Mirror #009 was assembled and the results achieved on this and subsequent mirrors showed that there were still many variables involved with the use of the Stycast epoxy which are uncontrolled or uncontrollable. Figure 53 is a set of interferograms for both the IR and Visible sides and shows considerable saddling at the mounting points for both the arm return and top cap parts. It should be borne in mind that this mirror was assembled using the same fixture with all of the stress points relieved before and during initial cementing. In spite of this, a $1/4$ to $1/2$ fringe mirror ended up with the distortion shown in Figure 53. Prior to the temperature cycle and after at least 24 hours of air cure, this mirror showed practically no distortion on either side.

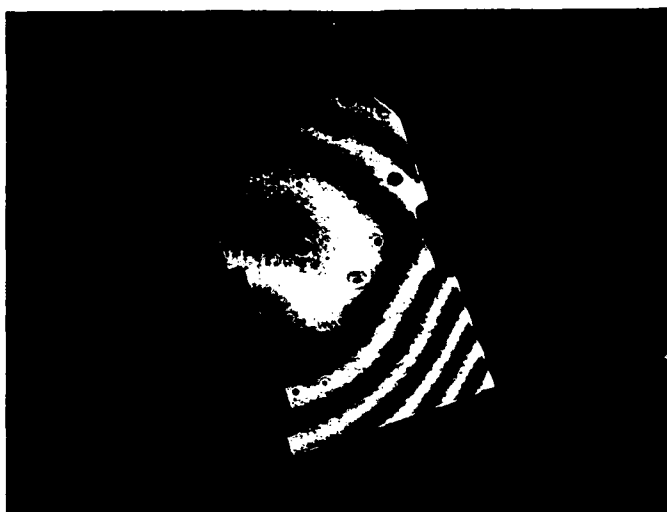
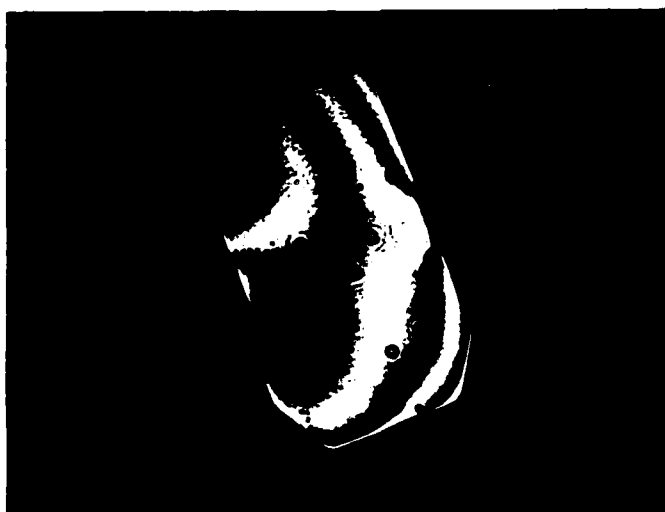
FIGURE 56. INTERFEROGRAMS, IR & VISIBLE SIDE, S/N 009A

The next mirror (S/N 009A) assembled used pyroceram substrate but the cement was changed to a glass-to-metal epoxy cement (MilBond) recommended for military applications (MIL-A-48611MU). In this case, all conditions were kept identical to those used for Mirror #009. All stress points on the fixture were relieved and optical flat survey was made of the mirror before and during the cementing process and after initial curing a check was made of the distortion in the mirror. After temperature cycling, the mirror showed between 1/4 and 1/2 fringe flatness with a considerably improved regularity compared to Mirror #009. Although the manufacturer specification indicated that the cure temperature of this cement was 71°C, the MilBond cement was subjected to the full NVL temperature cycle. Figure 56 shows a set of interferograms for both the IR and Visible side of this mirror after curing. The results are self-evident.

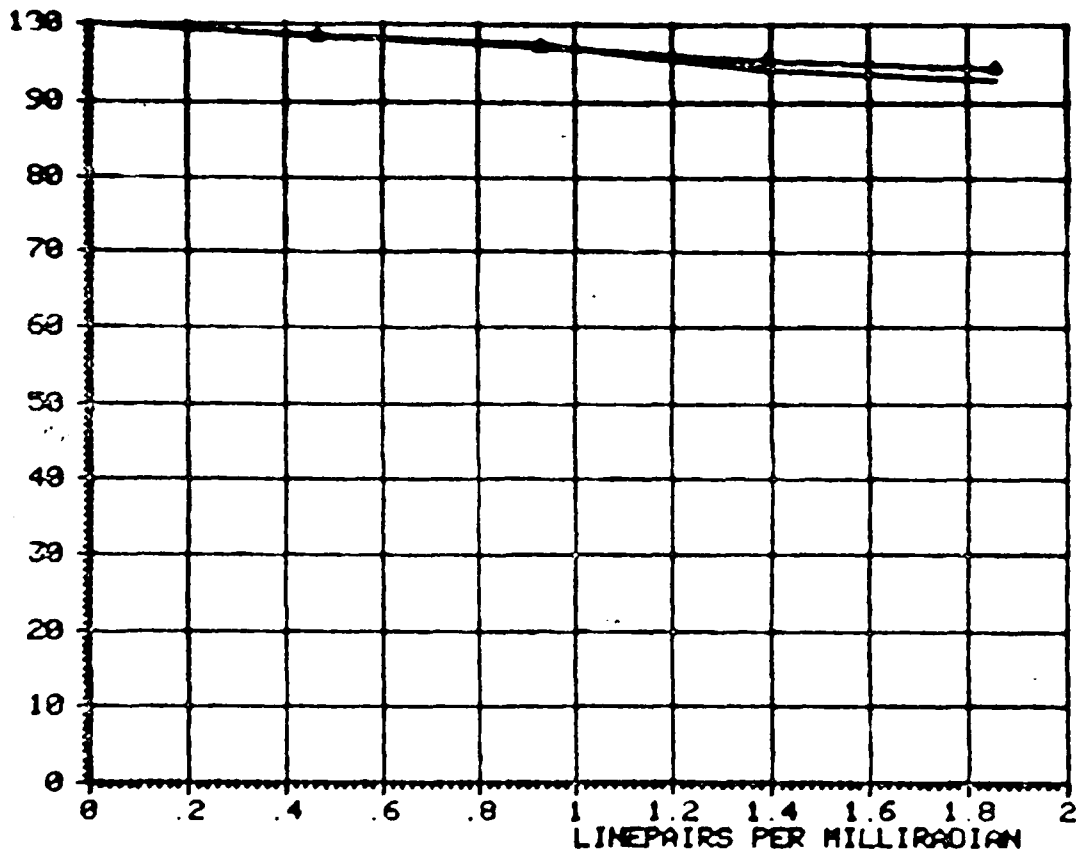
FIGURE 58. MTF RESPONSE, VISIBLE SIDE, S/N 009A

Figure 58 is a plot of the MTF response of the Visible side. This side has more than exceeded the specification requirements and in general the results are dramatic compared to Mirror #009, using exactly the same assembly techniques and procedures.

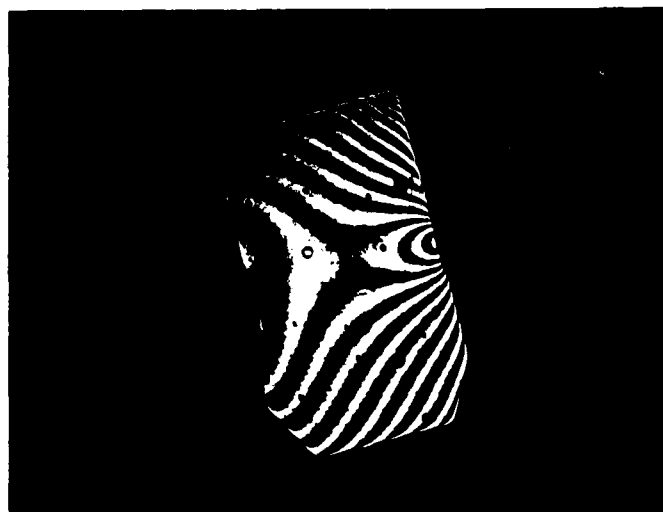
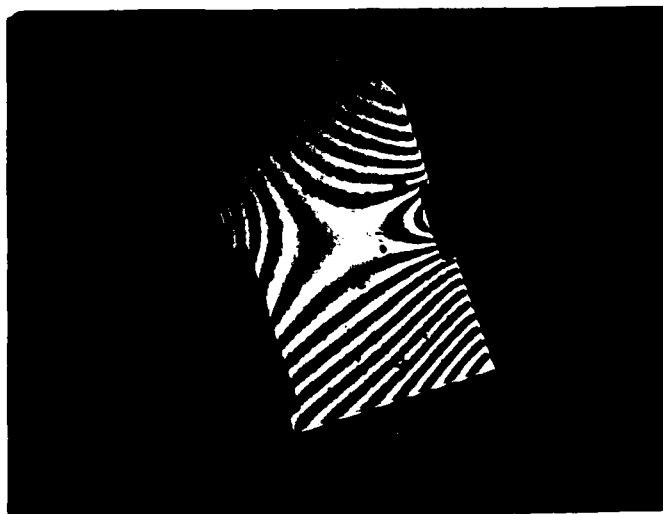
FIGURE 59. INTERFEROGRAMS, IR & VISIBLE SIDE, S/N 011

Figure 59 shows a set of interferograms taken on Mirror #011 using the Stycast epoxy and a single bond line. Stress inputs were carefully controlled and after 24 hours of air cure this mirror showed essentially the same results as Mirror #009 before temperature cycling.

Figure 59 now shows the end result of curing the Stycast once again. In this case, somewhat less saddling has resulted. It was impossible to determine what caused this distortion over and above that imposed by the cement curing. The only conclusion drawn was that the stress shown on these assemblies is strictly due to the Stycast epoxy.

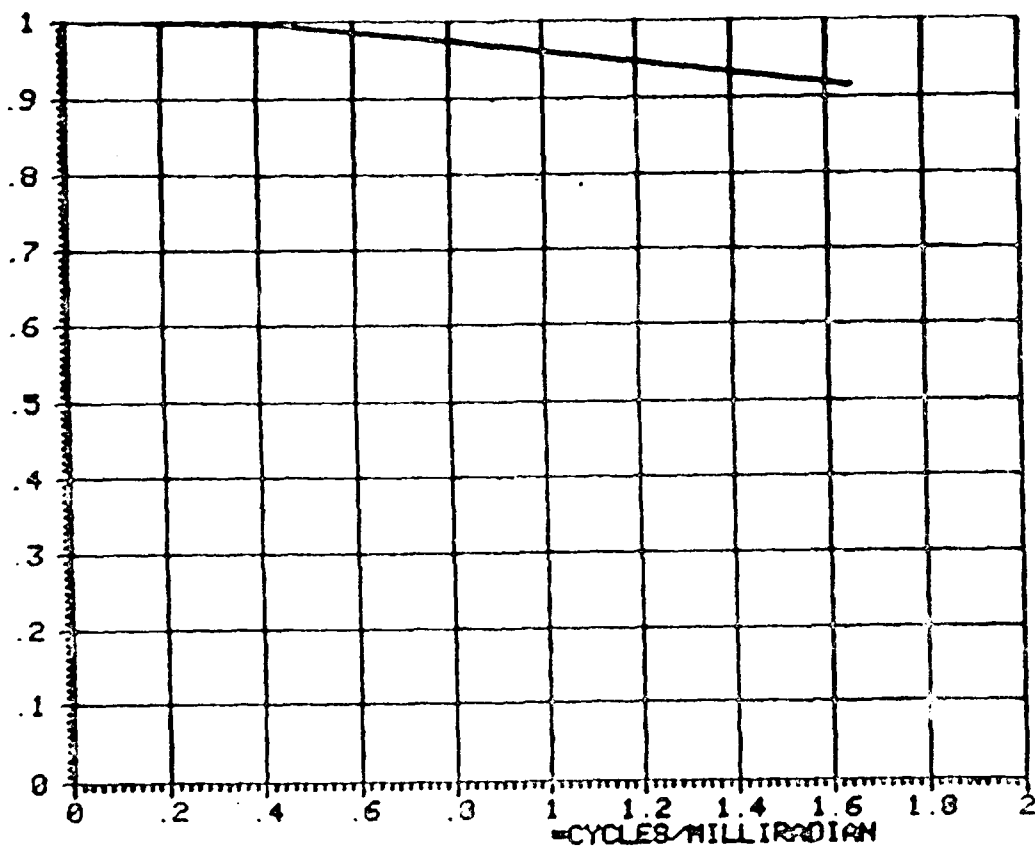
FIGURE 72. DYNAMIC MTF RESPONSE, IR SIDE,
SCANNER #003, MIRROR #009B

A dynamic MTF test was then run on this mirror. Figure 71 is the calibration curve obtained during this test. Figure 72 is a plot of the IR side MTF response. The response is certainly well within the specified limits and but for the depth of the saddle would not reflect what would be expected with the interferogram shown in Figure 73. All that could be said at this stage was that the mirror performance was far superior to that anticipated for this type of interferogram.

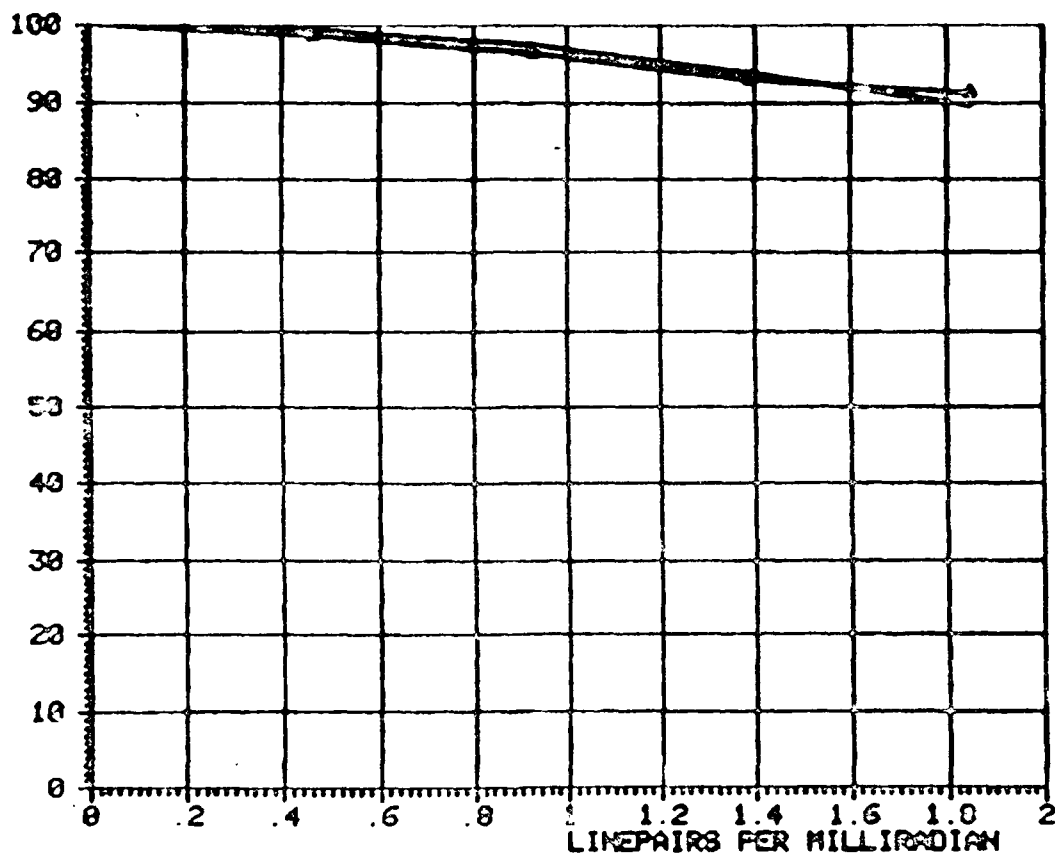
FIGURE 75. STATIC MTF RESPONSE, VISIBLE SIDE,
SCANNER #003, MIRROR #009B

The MTF response for the Visible side (Figure 75) shows some minor astigmatic change (as expected) but this side more than adequately meets the requirements for MTF.

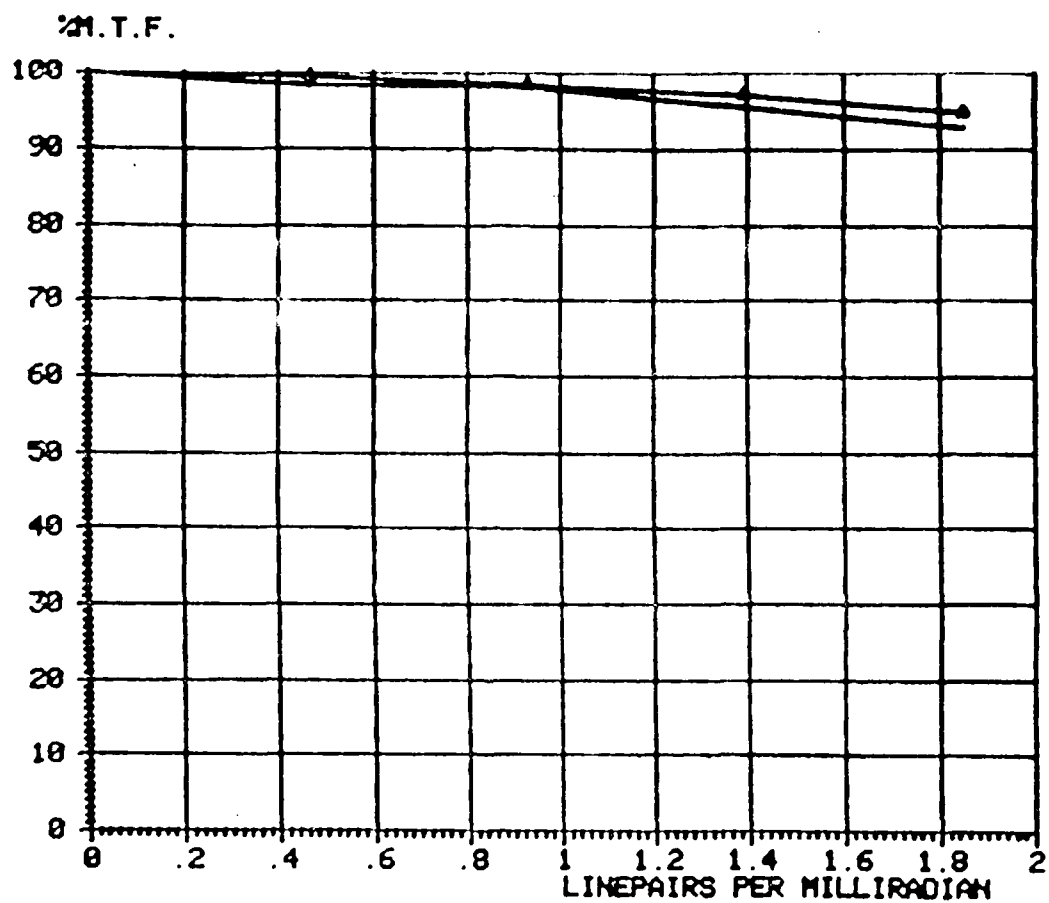
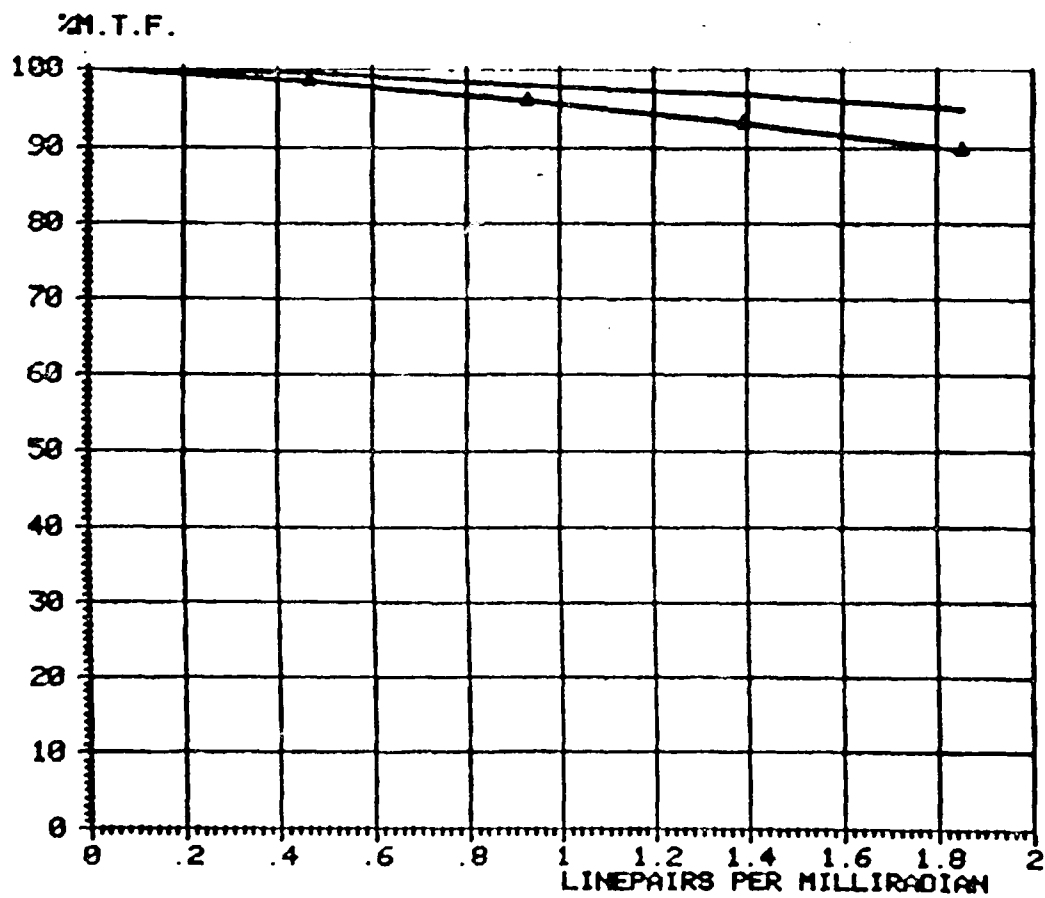
The MTF responses shown in Figures 80 and 81 show that the mirrors met the requirements. Moreover in this case the Visible side shows an attendant astigmatism which is consistent with the ellipticity shown in Figure 79.

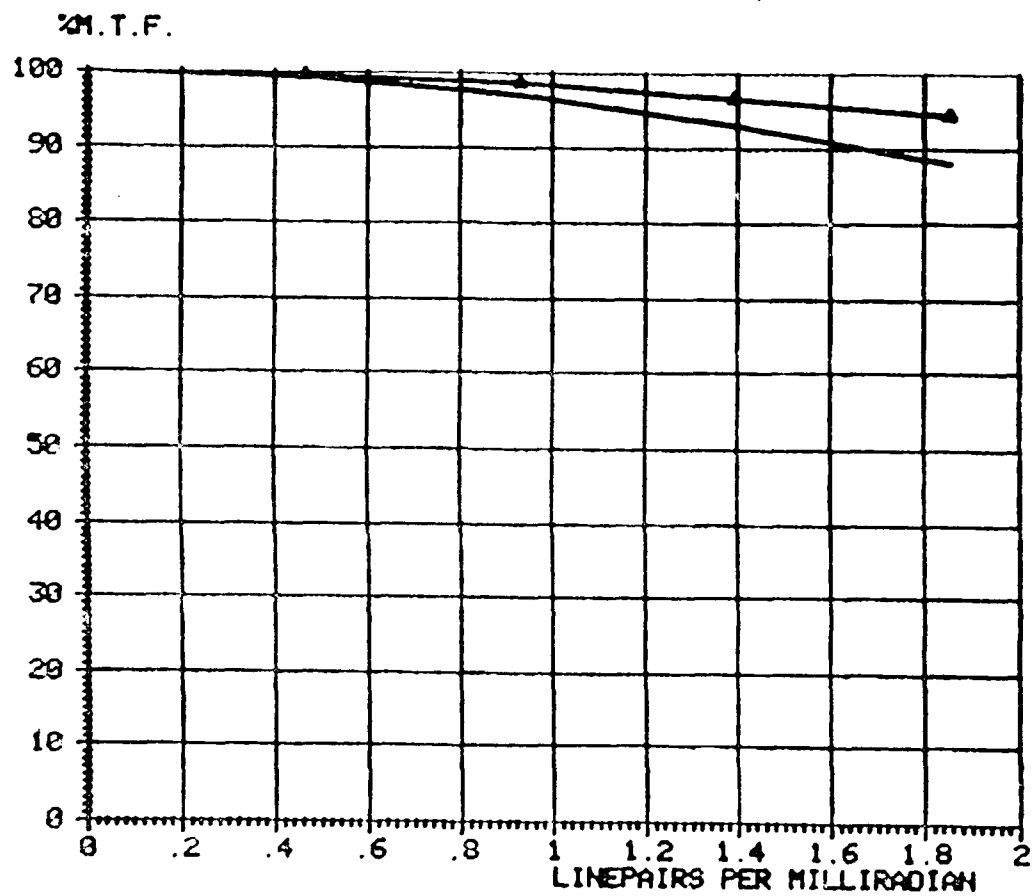
FIGURE 86. MTF RESPONSE, IR SIDE, MIRROR #016

Figure 86 is a plot of the MTF response of the IR side and shows some astigmatism. However, the MTF at .667 Lp/mr is well above the required .95 and is therefore acceptable. Figure 87 is the MTF response for the Visible side of the mirror. The response is flat enough to meet the .95 requirement to about 1-5 Lp/mr which is excellent.

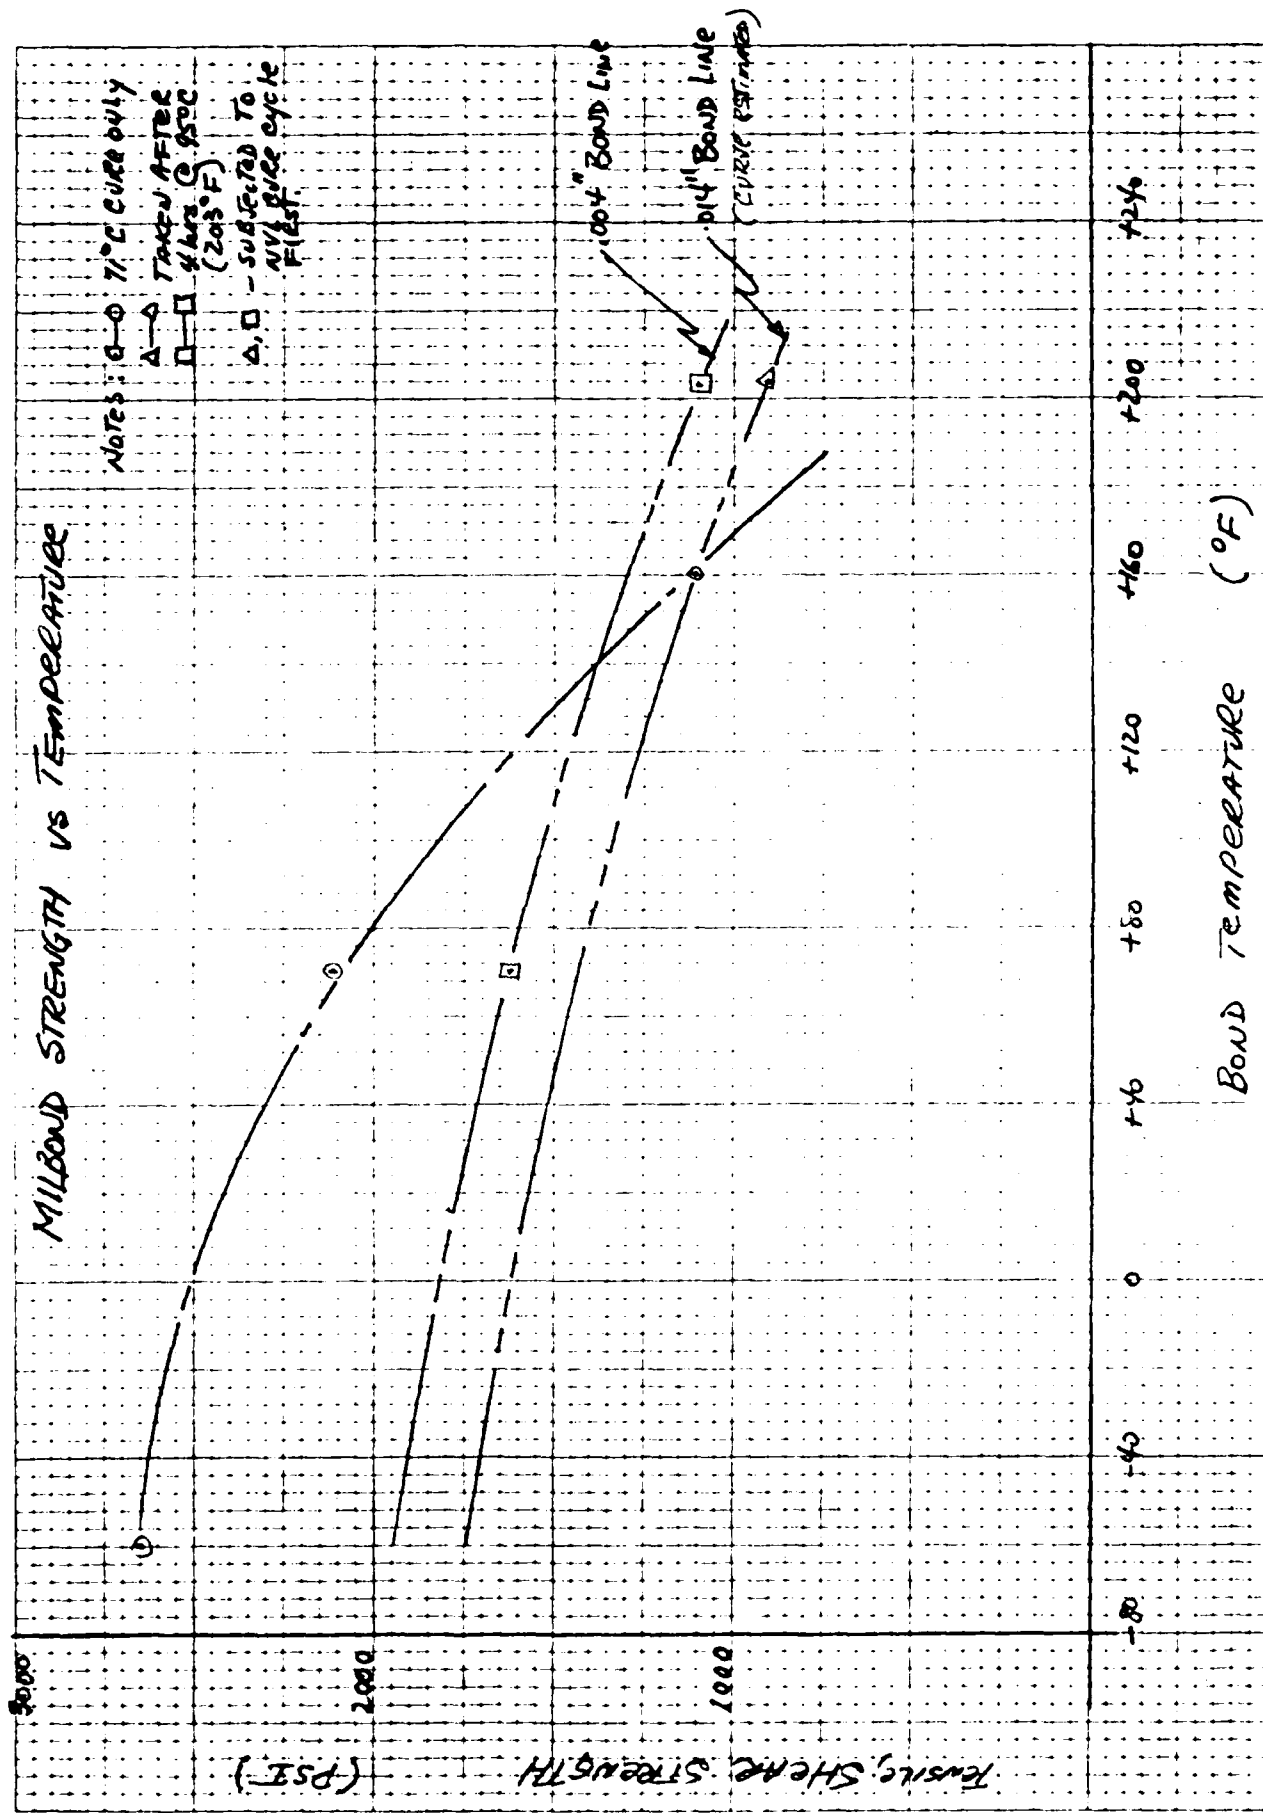
FIGURE 91. MILBOND STRENGTH VS TEMPERATURE

The average was taken for the two gap widths for each test and plotted against the original Milbond results obtained at Frankford Arsenal. These are shown in Figure 91. The temperature cycling (per NVL) has apparently reduced the low temperature strength by about 30% but has improved the high temperature strength by at least 75%. When the surface area of the mirror bond is examined, the total area (per side) is equal to .0945 in² for the arm return and .04095 in² for the minimum surface on the top cap. When the yield strength in tension for the .004" gap (1100 psi) is applied, the pull strength is 45# for the top cap. The worst case condition of 777 psi applied to the top cap yields a pull strength of 31.8 lbs @ 95°C. This is considered to be satisfactory.
